# Bushfire test on an external wall system

## Test Report

**Author:** Chris Wojcik  
**Report number:** FSZ 2373  
**Date:** 9 June 2023

## Sponsored Investigation No. FSZ 2373

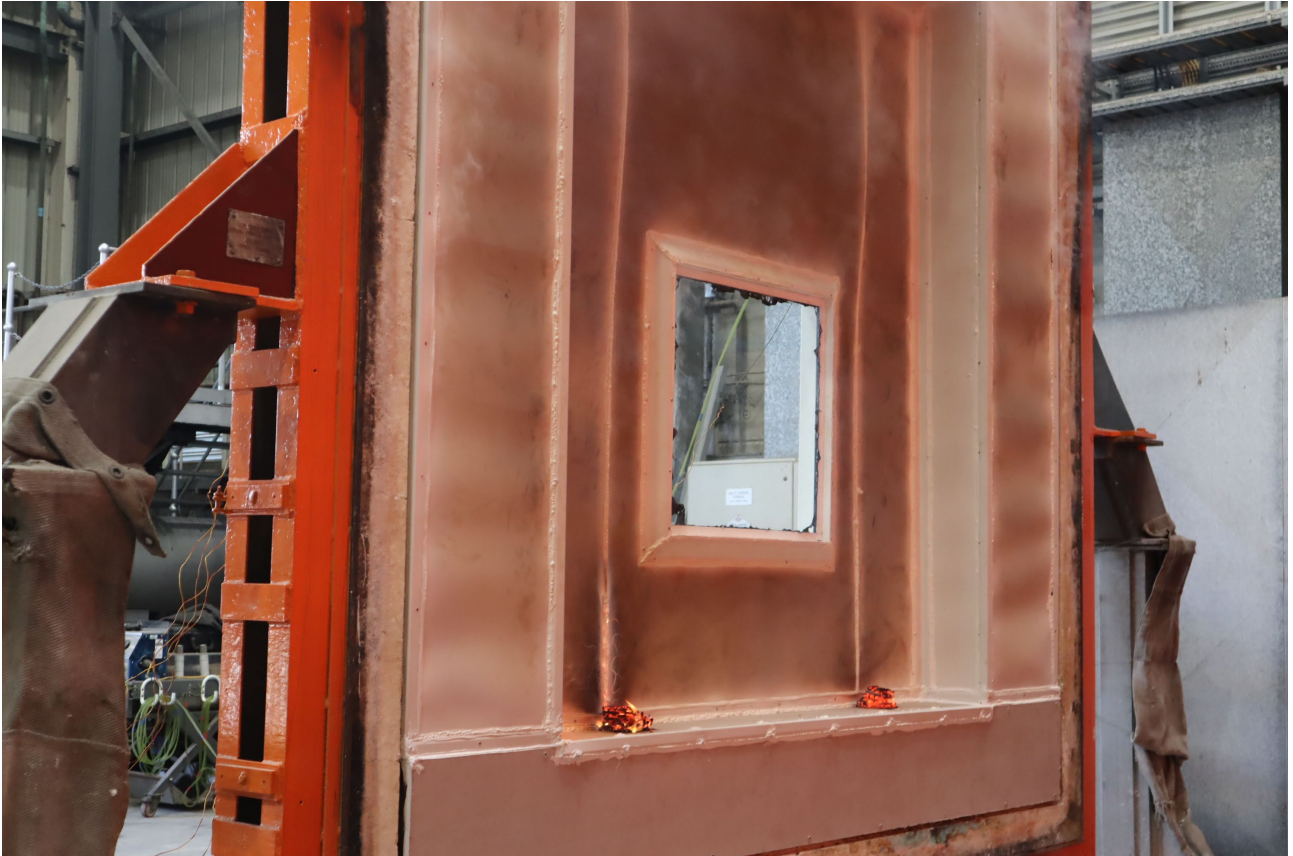
- 2:25 minutes - Specimen moved in position – exposure to 21 kW/m<sup>2</sup>.
- 3:18 minutes - Crib #3 has ceased flaming.
- 3:25 minutes - Specimen moved in position – exposure to 14 kW/m<sup>2</sup>. Seals around the exposed side of perimeter of the window are starting to melt, photograph 10.

**PHOTOGRAPH 10 – EXPOSED FACE OF SPECIMEN DURING 14 KW/M<sup>2</sup> EXPOSURE**

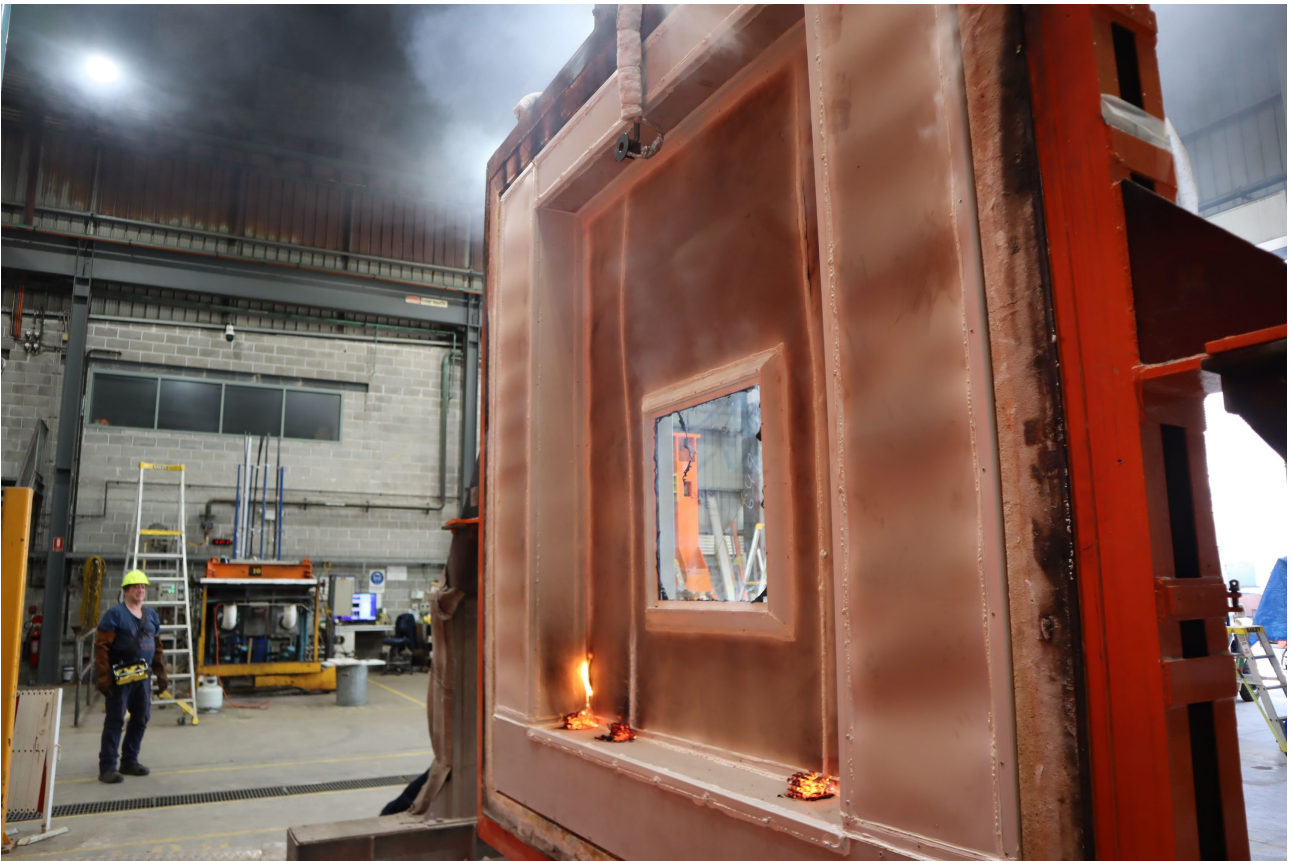
Three cribs were used, crib #1 was located in the internal corner of the wall rebate, Crib #2 was located adjacent to the panel joint left of the window, while crib #3 was located adjacent to the panel joint right of the window, as shown in Photograph 11 (Appendix B).

**PHOTOGRAPH 11 – EXPOSED FACE OF SPECIMEN DURING 11 KW/M<sup>2</sup> EXPOSURE**

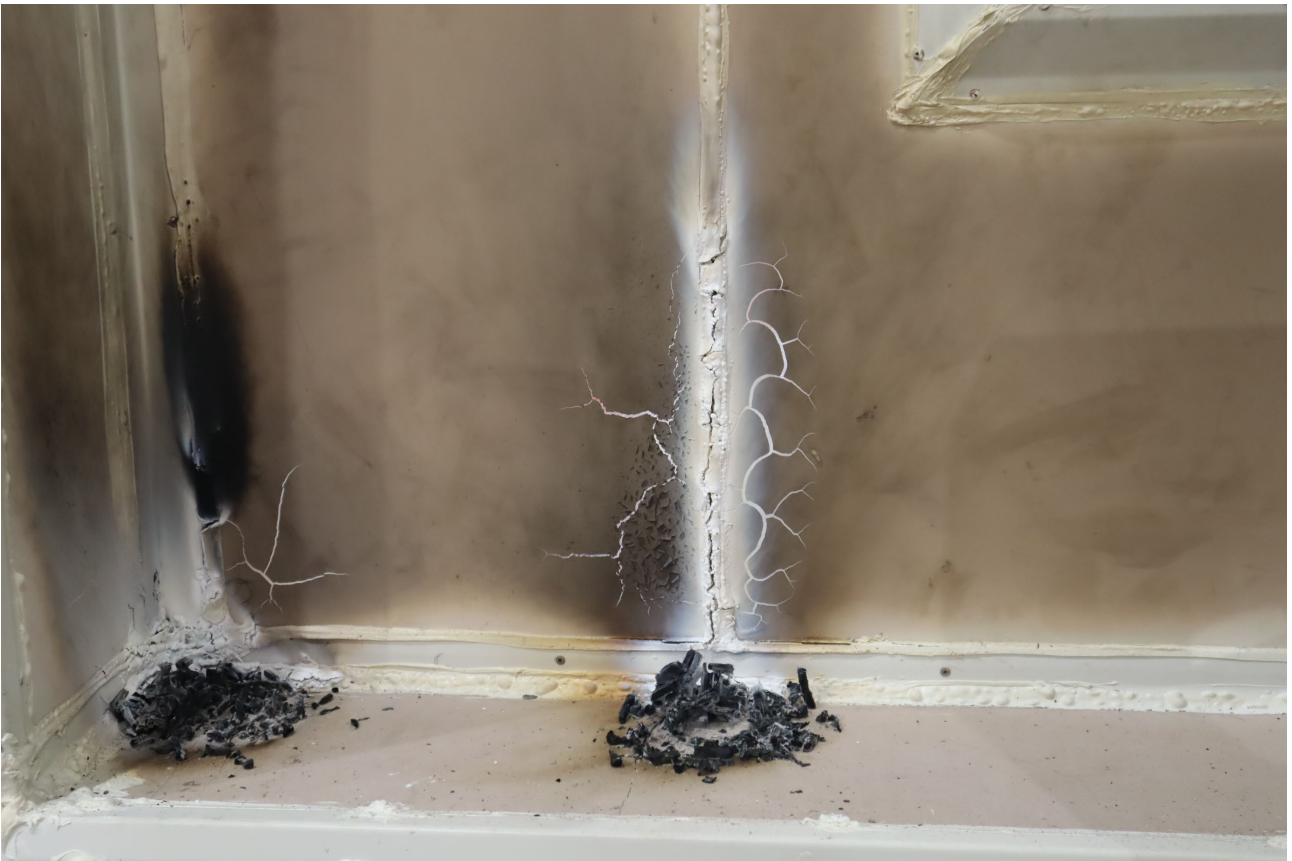
- 15 minutes - Radiant heat source shielded from the specimen. Radiometer is positioned 250-mm from the exposed face of the wall specimen in front of the inside corner, adjacent to crib #1. Cracks in the sealant along the panel joint adjacent to crib #2 have been observed, photograph 17.

**PHOTOGRAPH 17 – EXPOSED FACE ADJACENT TO CRIB #1 AND #2 AT 16 MINUTES INTO THE TEST**

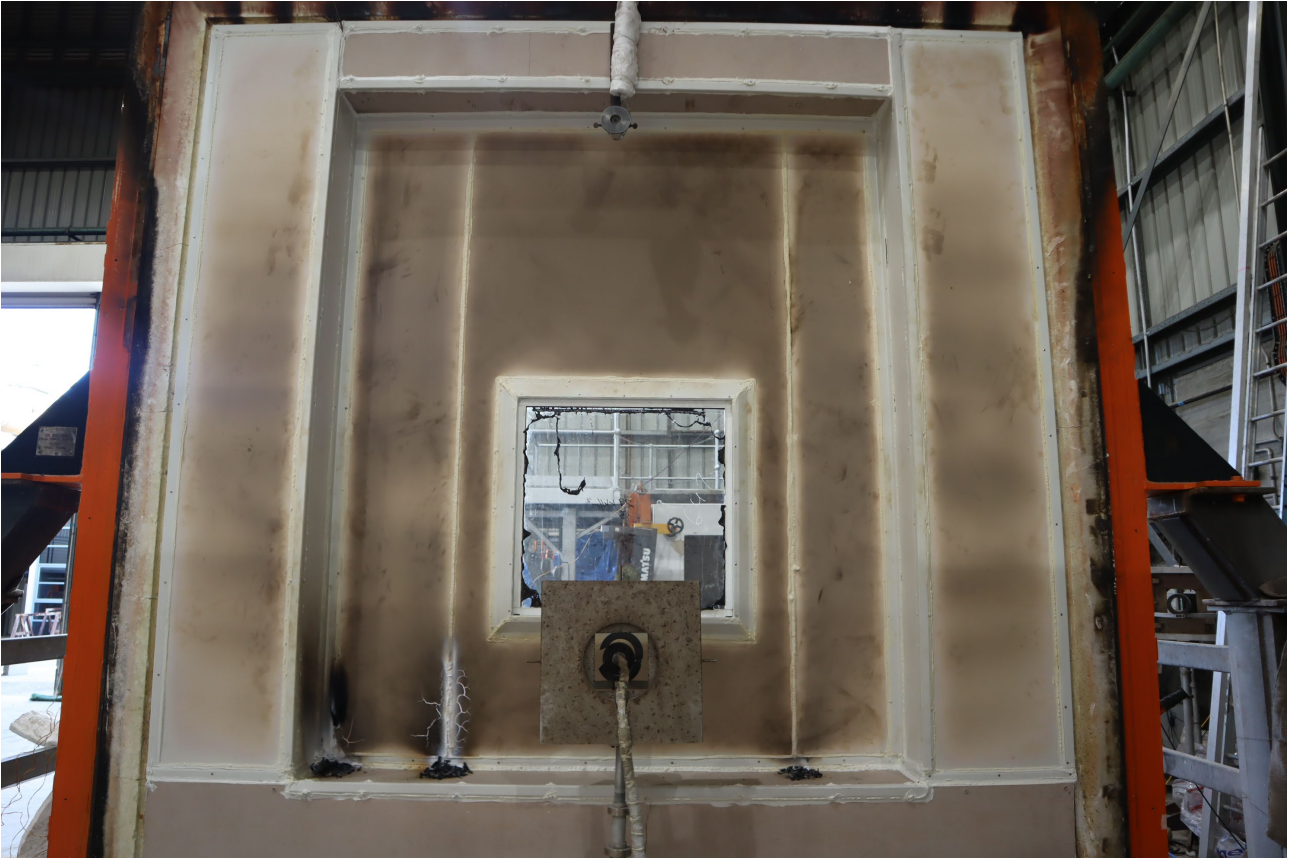
- 20 minutes - Pilot flame was applied over the exposed face of the specimen – no ignition was noted at this time. 3-mm gap gauge applied to the specimen – No through gaps were noted.
- 58 minutes - Pilot flame was applied over the exposed face of the specimen – no ignition was noted at this time.
- 61 minutes - Test terminated.
- Post Test Inspection 3-mm gap gauge applied to the specimen – no through gaps were noted.

**PHOTOGRAPH 18 – EXPOSED FACE OF THE SPECIMEN AT THE CONCLUSION OF TESTING**
