Bushfire test on a roof system

Test Report

Author:Peter GordonReport number:FSZ 2411

Bushfire test on a roof system Sponsored Investigation No. FSZ 2411

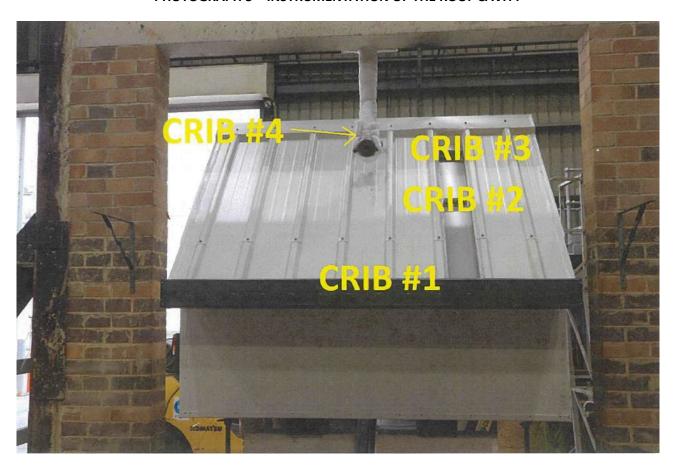
Four cribs were used for the test, crib #1 was positioned in the roof gutter adjacent to the ridge edge of the valley gutter, while Cribs #2 and 3 were positioned in the valley gutter 700-mm and 1200-mm from the drip edge. Crib # 4 was positioned just below the ridge cap detail mid span as shown in Photograph 4 (Appendix A).

PHOTOGRAPH 4 – EXPOSED FACE OF THE SPECIMEN SHOWING CRIB LOCATIONS PRIOR TO TESTING

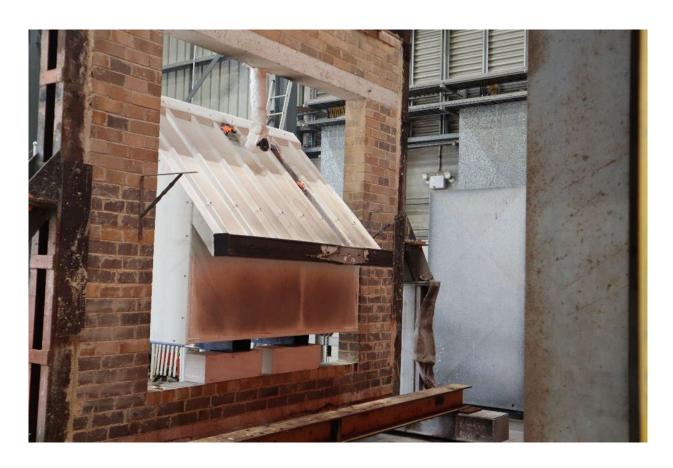
PHOTOGRAPH 11 – EXPOSED FACE SPECIMEN AT 5 MINUTES INTO THE TEST

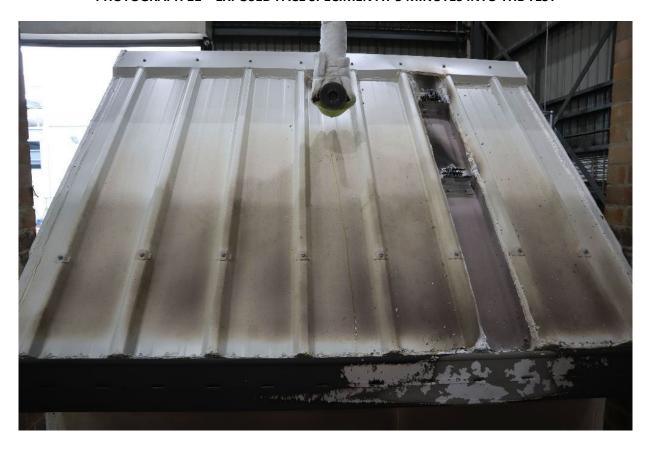
15 minutes - Radiant heat source shielded from the specimen. No flaming, cracking or signs of

any 3-mm through gaps.

PHOTOGRAPH 12 – EXPOSED FACE OF SPECIMEN AT 15 MINUTES INTO THE TEST

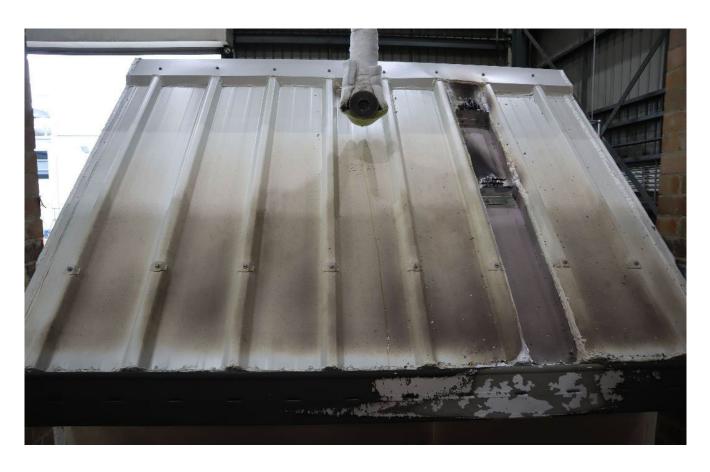
PHOTOGRAPH 13 – EXPOSED FACE OF SPECIMEN AT 15 MINUTES INTO THE TEST

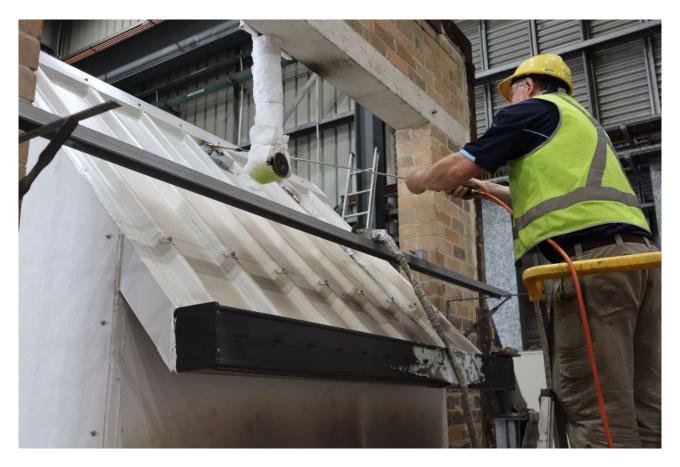
PHOTOGRAPH 14 – EXPOSED FACE OF THE SPECIMEN AT 32 MINUTES INTO THE TEST

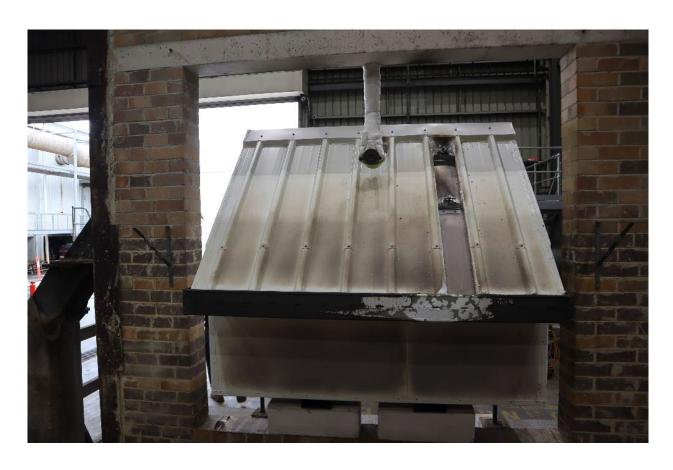
PHOTOGRAPH 15 - EXPOSED FACE OF THE SPECIMEN AT THE CONCLUSION OF TESTING

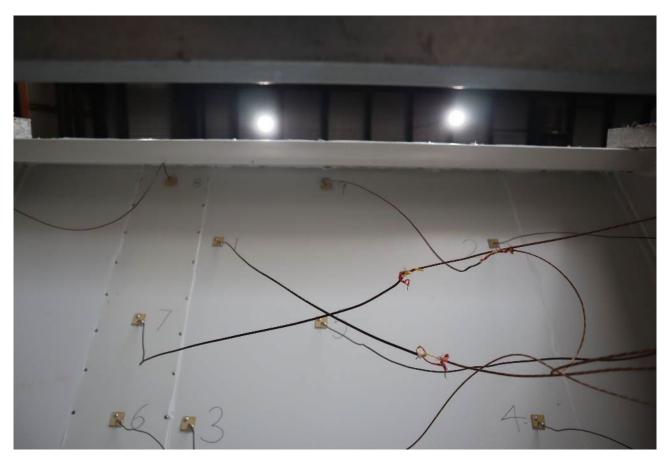
Post test, the back face of the roof assembly was removed to check for any gaps around the vents from inside the roof cavity. No through gaps >3-mm were found

in the specimen.

PHOTOGRAPH 16 – UNEXPOSED FACE OF THE ROOF CAVITY AFTER THE CONCLUSION OF TESTING

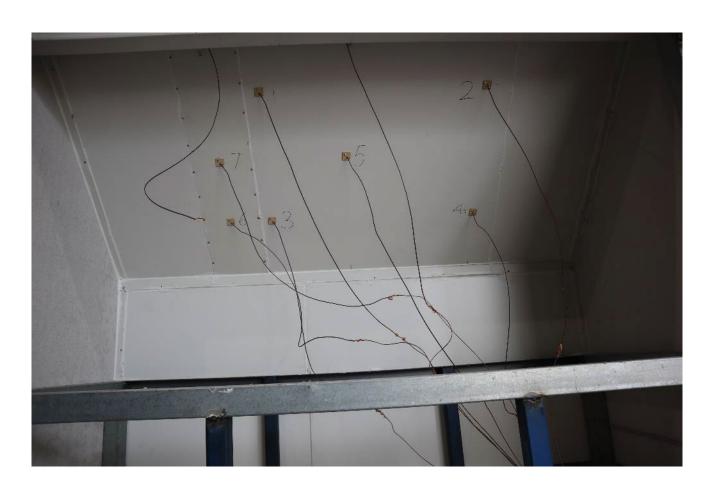
PHOTOGRAPH 17 – UNEXPOSED FACE OF THE ROOF CAVITY AFTER THE CONCLUSION OF TESTING

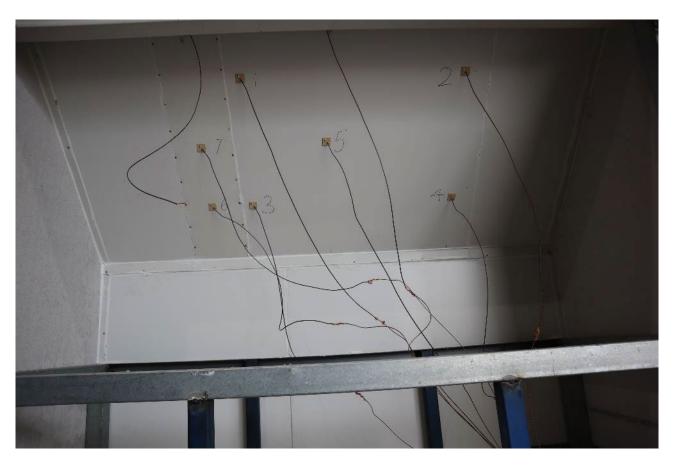
PHOTOGRAPH 18 – UNEXPOSED FACE OF THE ROOF CAVITY AFTER THE CONCLUSION OF TESTING

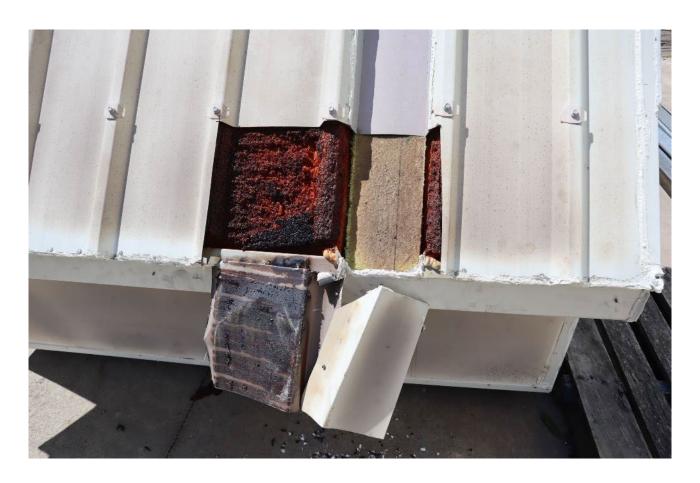
PHOTOGRAPH 19 – UNEXPOSED FACE OF THE ROOF CAVITY AFTER THE CONCLUSION OF TESTING
