# FIRE TEST REPORT

## FR10430-001 ISSUE 2

### THE FIRE RESISTANCE OF A NON-LOADBEARING DELTACOOOL-MW PANEL WALL IN ACCORDANCE WITH AS 1530.4:2014

To determine the fire resistance of a nominally 100 mm thick DeltaCool-MW insulated panel wall assembly when tested in accordance with AS 1530.4:2014 “Methods for fire tests on building materials, components and structures, Part 4: Fire–resistance test for elements of construction.”

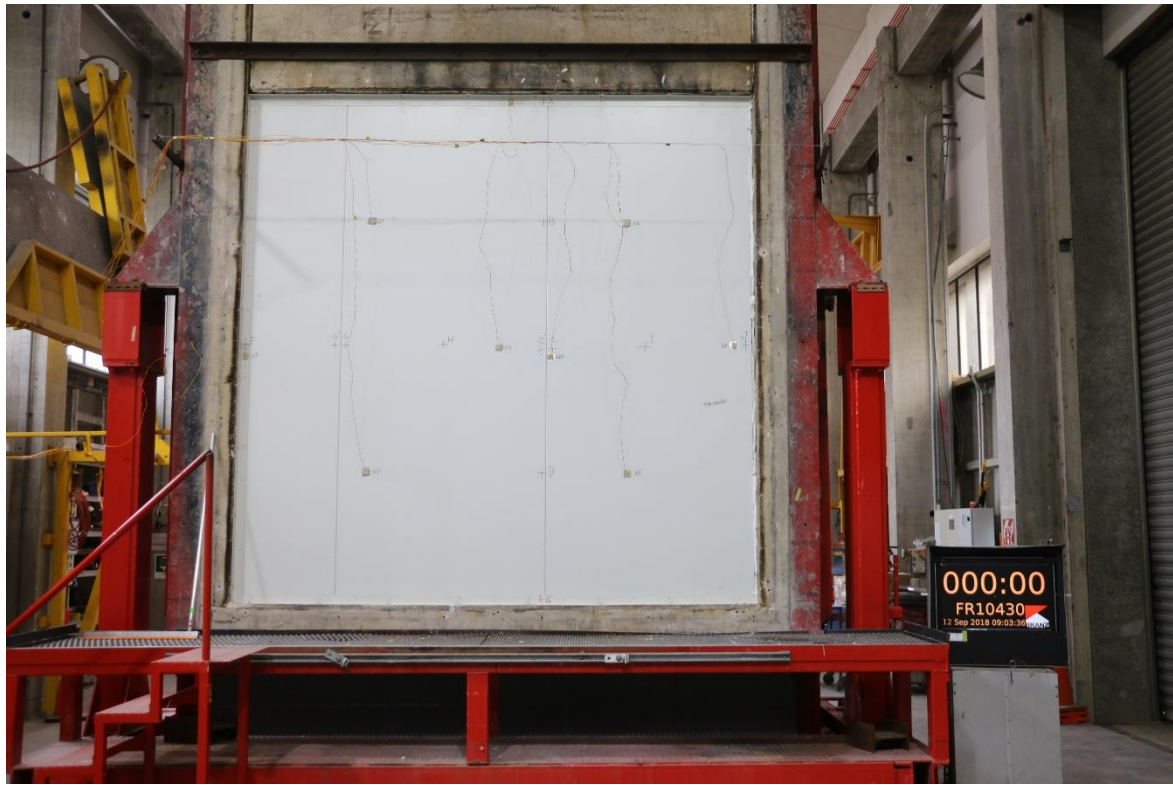
Photo 1: The Unexposed Face of the Specimen Prior to Testing

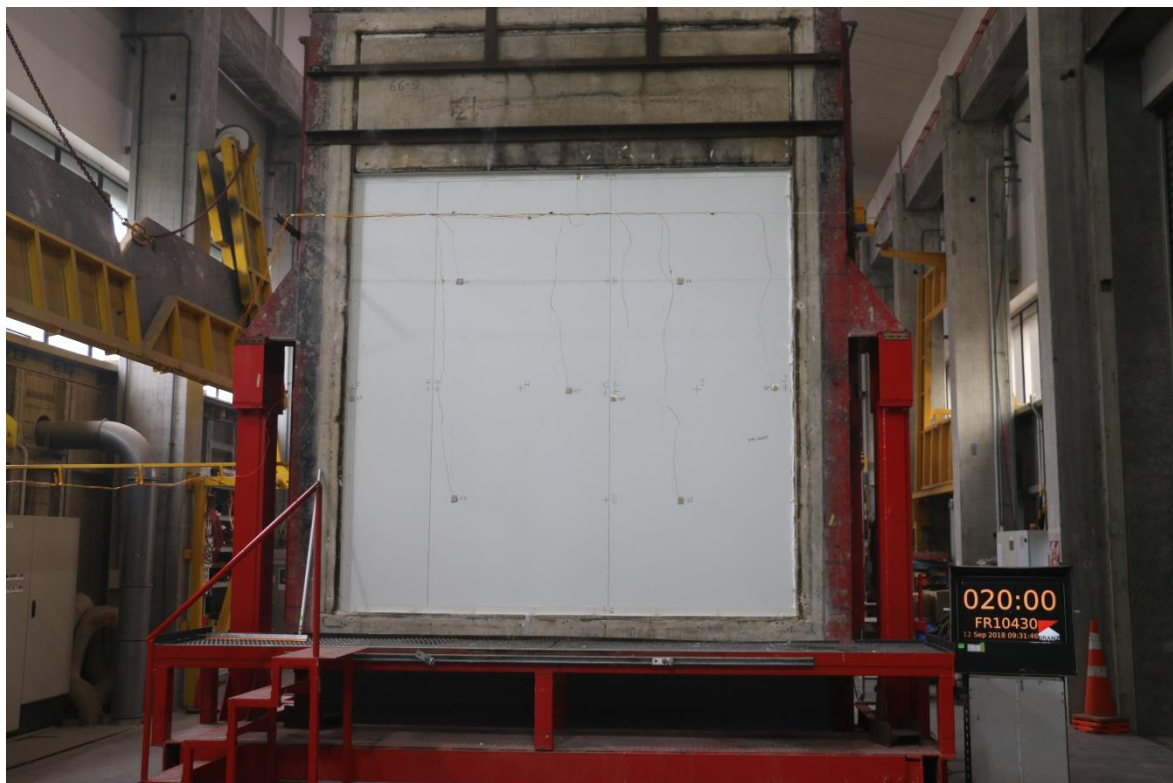
Photo 2: The Unexposed Face of the Specimen After a Duration of 20 Minutes

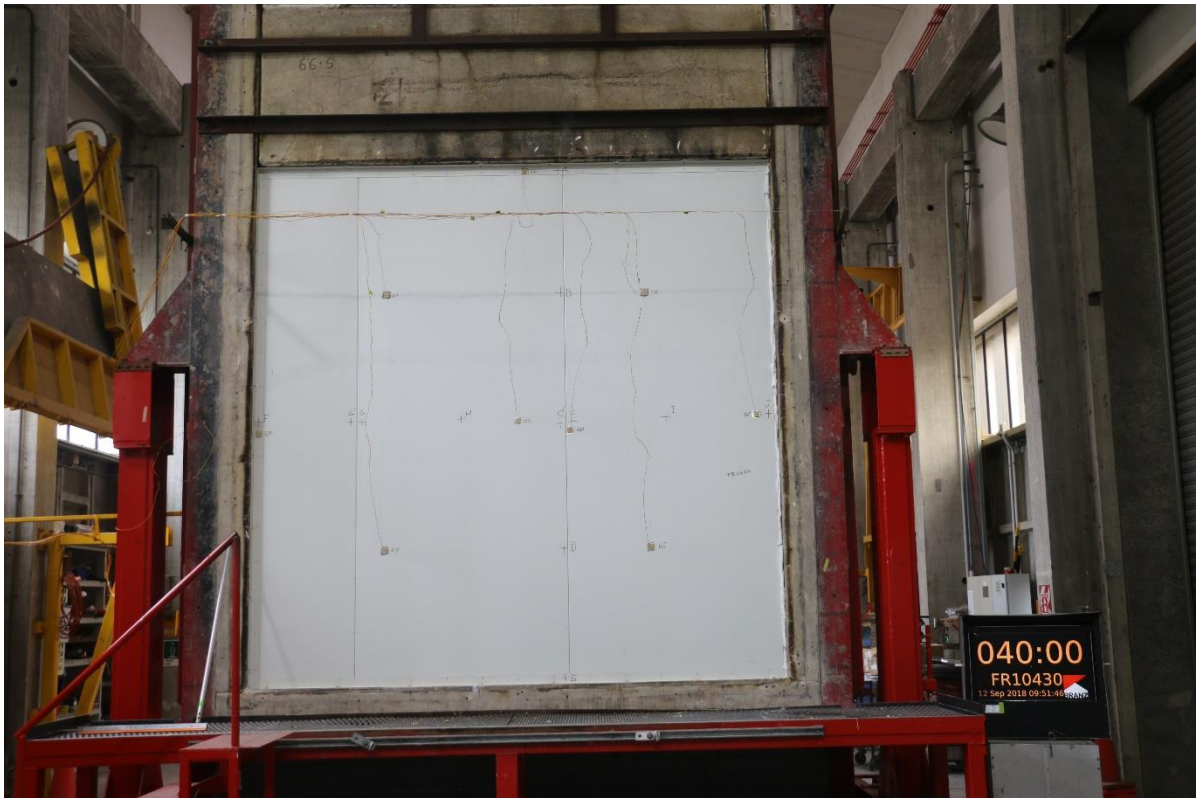
**Photo 3: The Unexposed Face of the Specimen After a Duration of 40 Minutes**

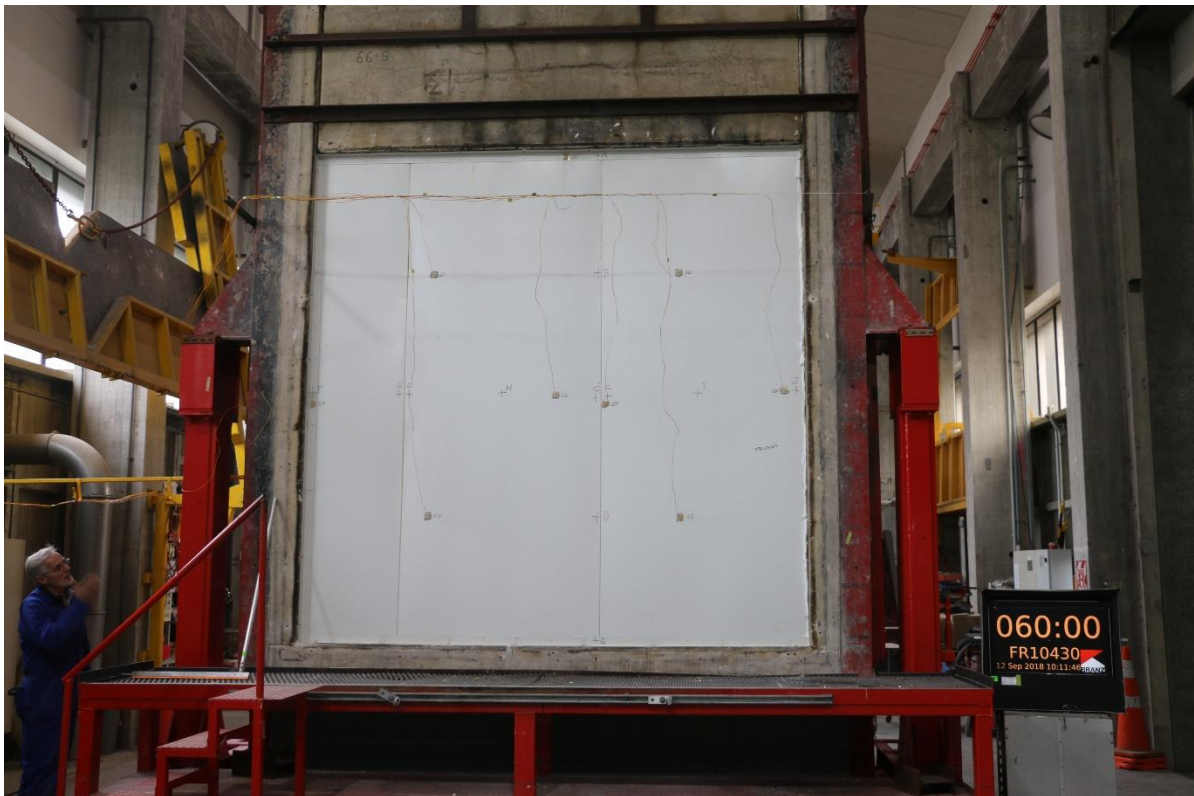
**Photo 4: The Unexposed Face of the Specimen After a Duration of 60 Minutes**

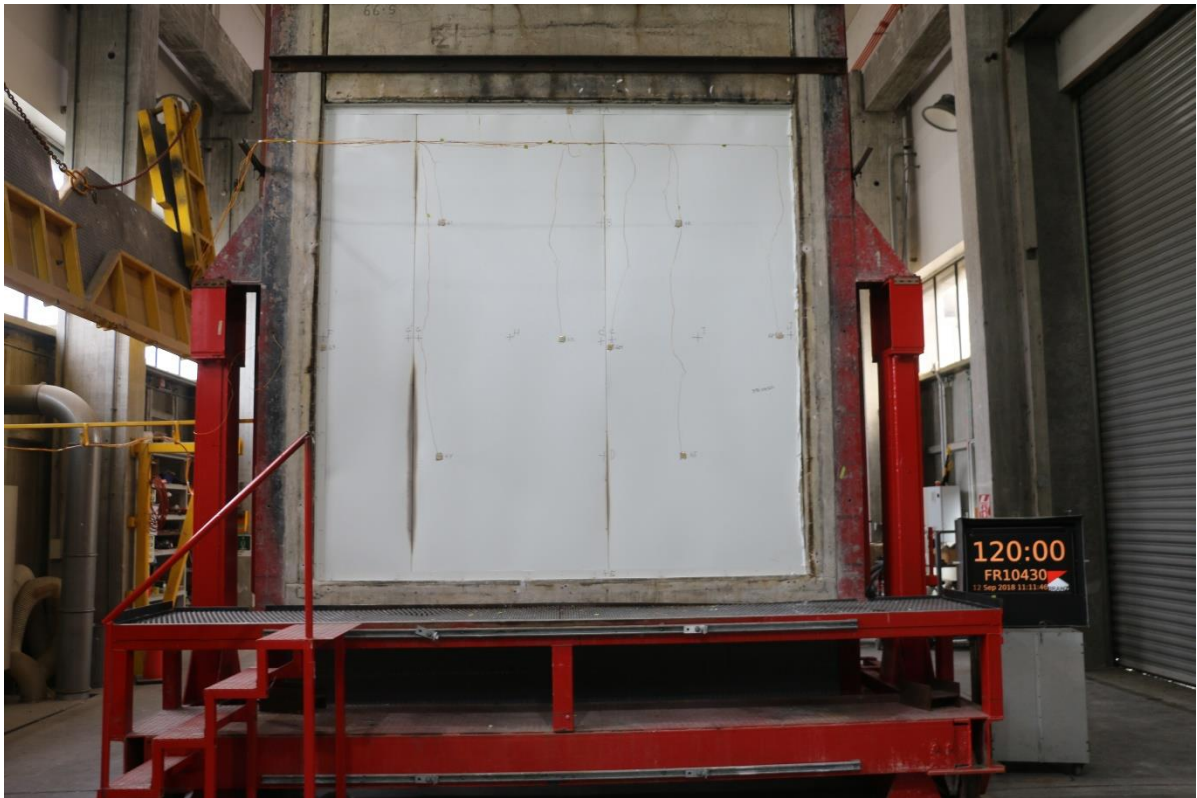
**Photo 5: The Unexposed Face of the Specimen After a Duration of 120 Minutes**

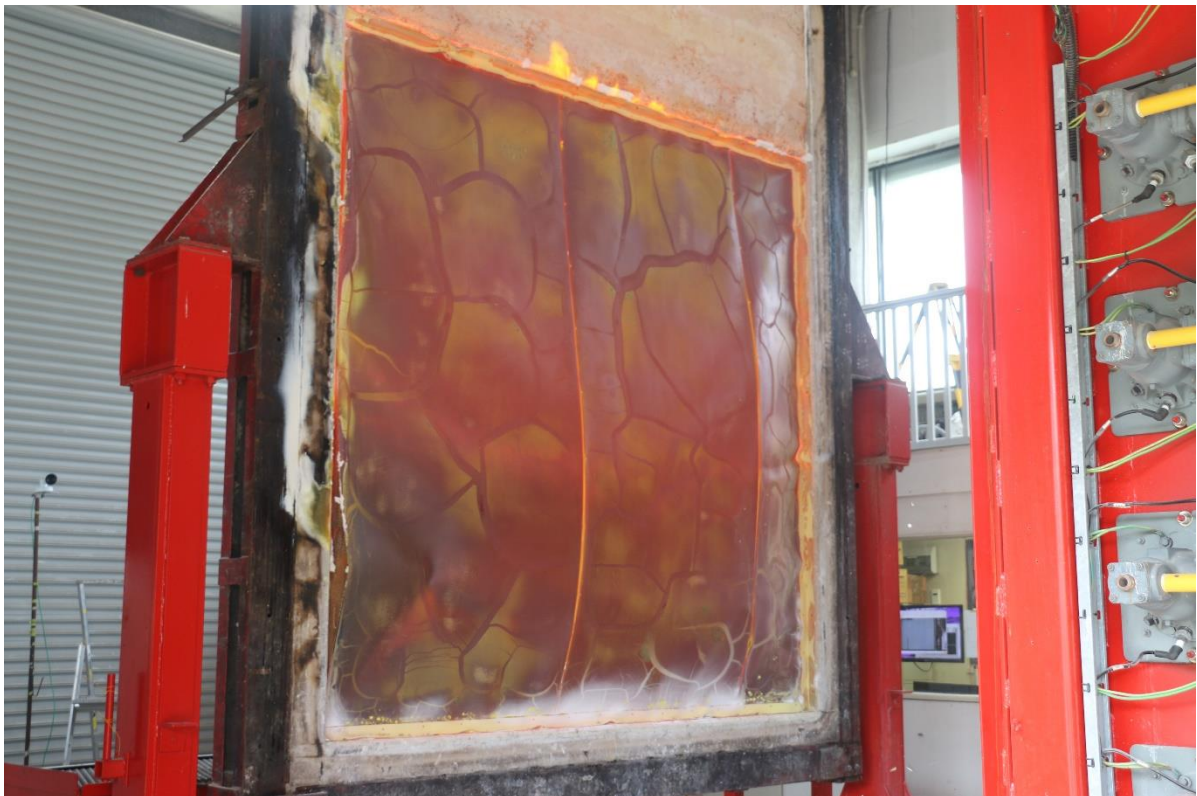
**Photo 6: The Exposed Face of the Specimen Immediately After Testing**
